Notes for report

Site identification:

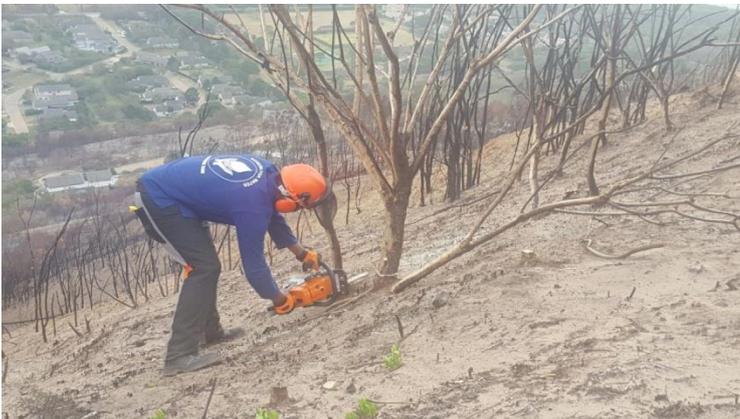
- Felling and scaling down of dead brush and trees

CHAIN SAW WORK ON BRENTON SLOPES

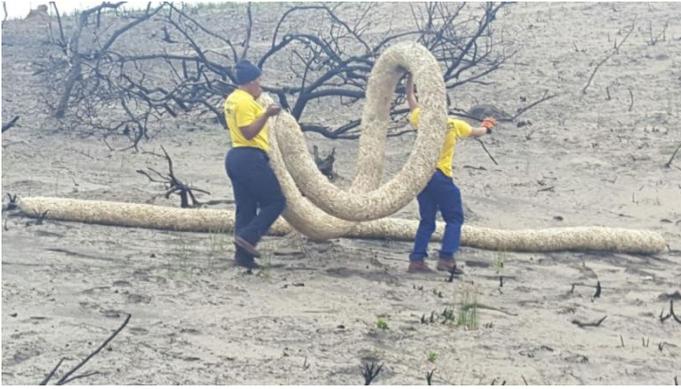
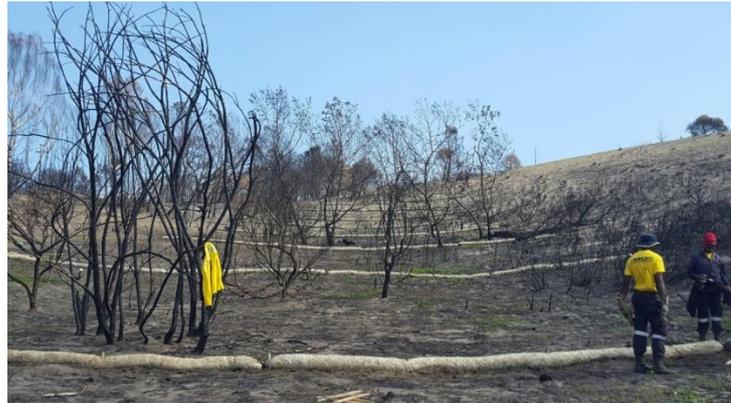
- Stacking of biomass along contour lines

- To prevent/ limit further sheet erosion
 - Stacked lines provide a micro habitat, allowing faster plant regeneration/ re-growth
 - Opening of terrain for easy access (for herbicide application) to expected alien invasive plant control after plant regeneration.
- **Installing Bio-sausages/ Berms** to slow water velocity, and prevent/ reduce sediment flow along steep slopes

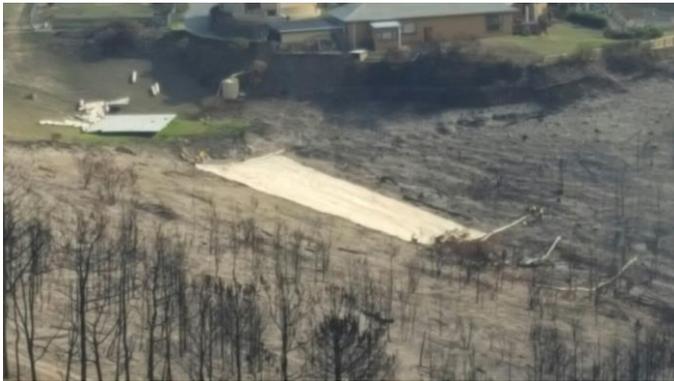
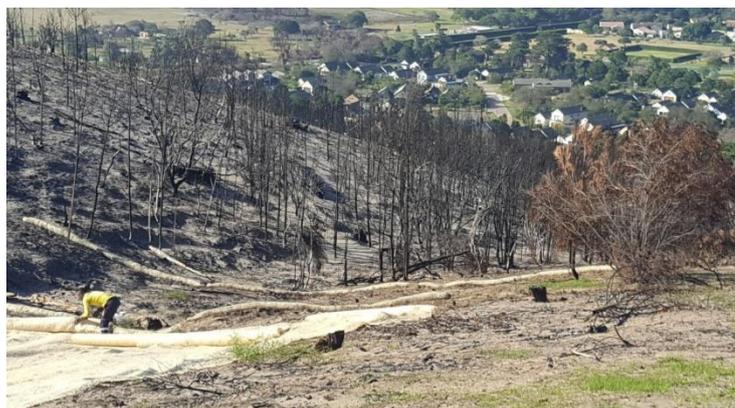
- Seeding of slopes above Berms/ Bio-sausages to fast track re-growth of ground cover
- Installing Bio-blankets to limit sediment flow, reduce water velocity, retain top soil, and boost re-growth potential

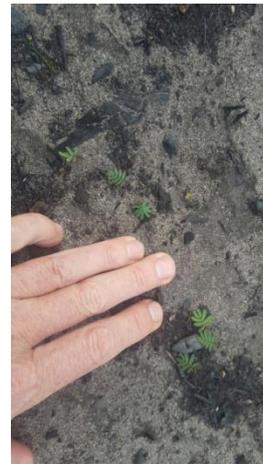
- Prepare terrain for hydro mulching
- Monitoring plant regeneration for invasive alien plant re-growth
- Development of capacity to address large-scale invasive alien plant re-growth

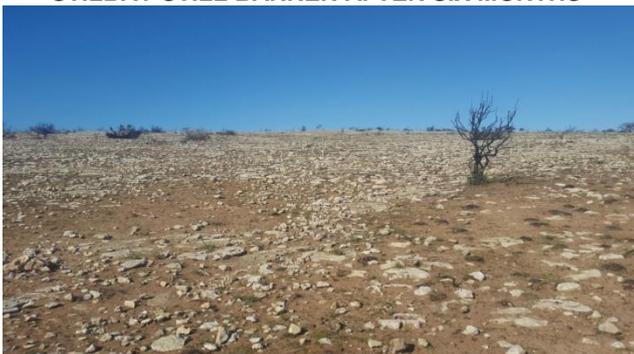
- Re-growth is painfully slow following low rainfall.
- Growth of invasive aliens already visible in areas previously effected by invasive alien plants - Approx. 6000 hectares affected
- Landowners willing to treat all new growth if herbicide assistance could be provided.
- Areas suitable for aerial spray not yet identified.
- Mapping exercise and ground verification recommended

STILBAY STILL BARREN AFTER SIX MONTHS
